1. AGENCY USE ONLY (Leave blank)		2. REPORT DATE Febraruy 2001	3. REPORT TYPE AND DATES COVERED Inspection	
4. TITLE AND SUBTITLE Lower Granite Dam Radial Gate Inspection and Testing			5. FUNDING NUMBERS

# Lower Granite Dam

## Radial Gate Inspection and Testing

US Army Corps of Engineers, Walla Walla District

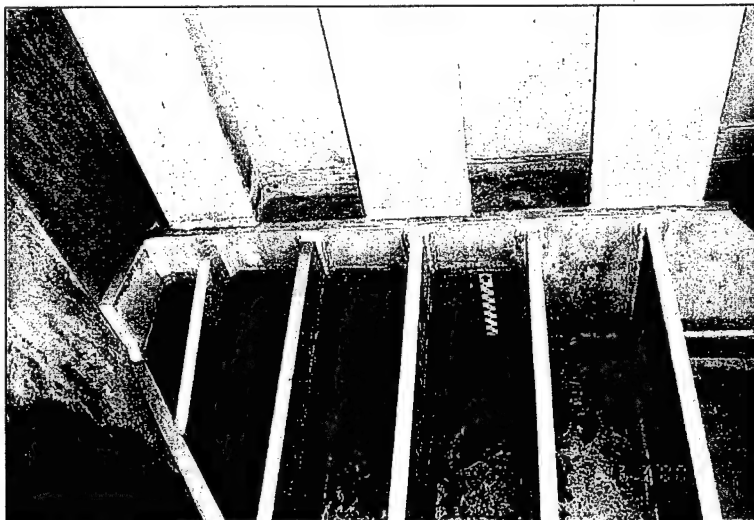
The worst corrosion occurs on the bottom horizontal girder, between the multiple stiffeners, at each end of the girder. There are six stiffeners in close proximity to one another with drainage only provided horizontally through a notch at the upstream (low) end of the stiffener. In order for the last space to drain, the water must travel horizontally under five stiffeners. These notches are typically clogged and the area between the stiffeners is consistently full of water and debris, see Photo. 11.

***Photo. 11: Standing water between stiffeners at ends of bottom horizontal girder, typical.***

- Install drain hole between the multiple stiffeners at ends of the bottom horizontal girders. The recommended size for these drain holes is 1-inch in diameter.

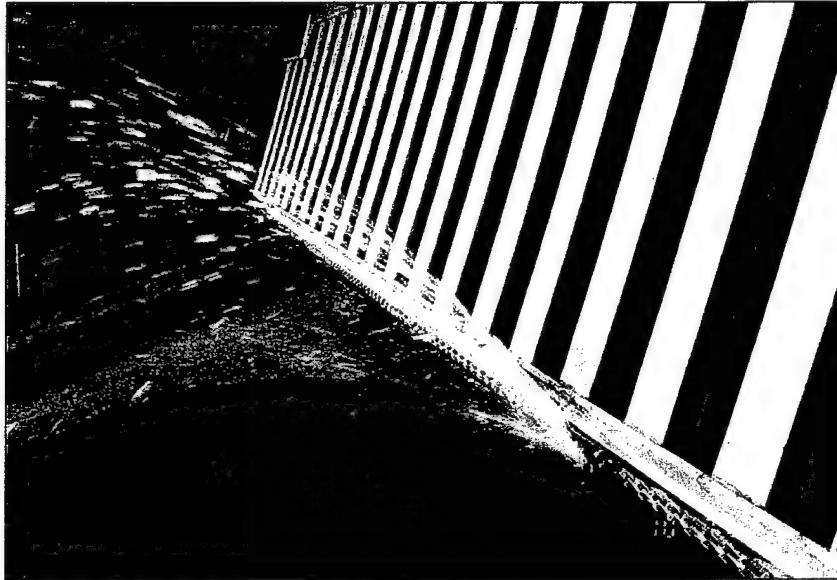
The side and bottom seals are in generally good condition. Small side and bottom seal leaks are visible on many of the gates, although no major leaks were observed. There is a leak at the bottom seal, at the spillway monolith construction joint at nearly every gate. Photo. 15. The

***Photo. 15: Leak at spillway monolith construction joint, typical.***

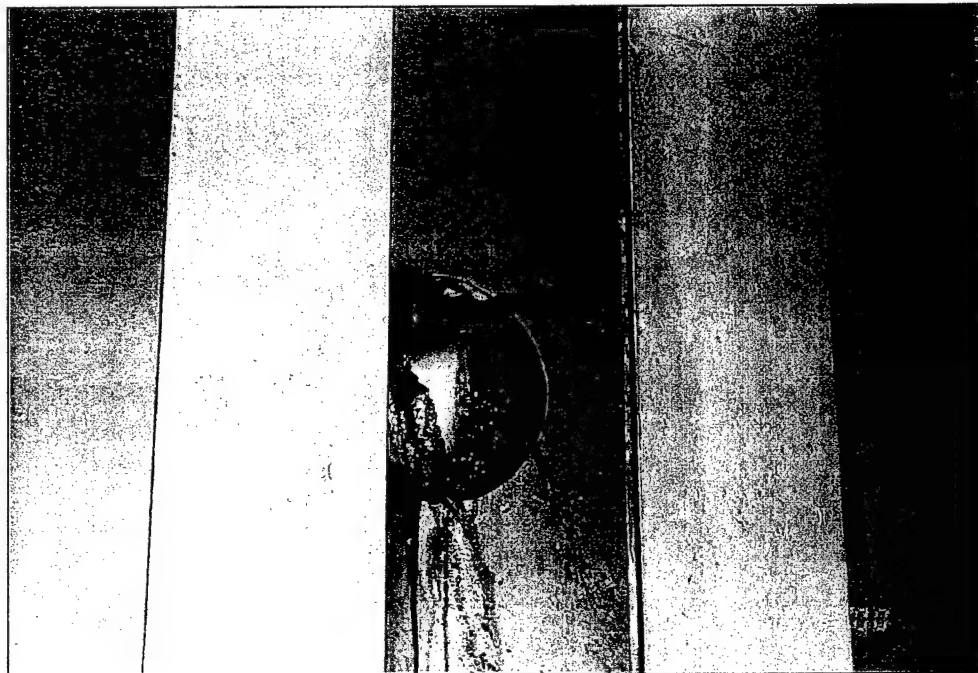
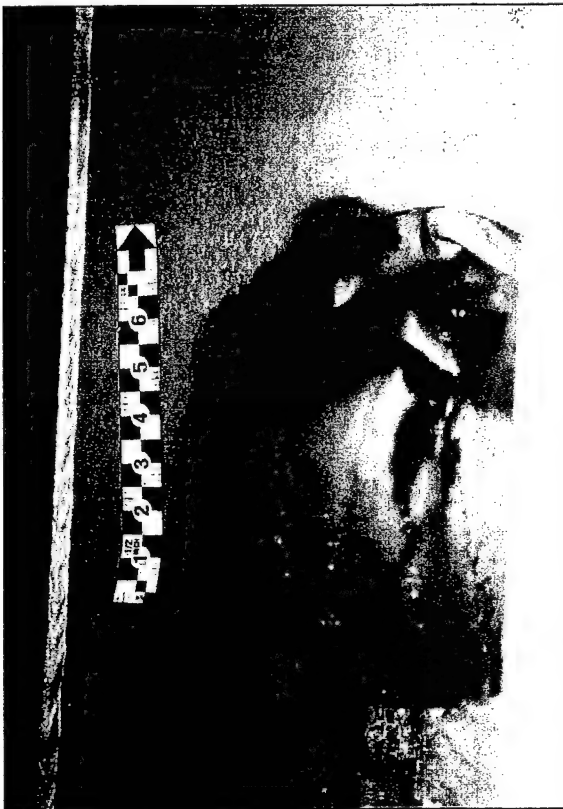
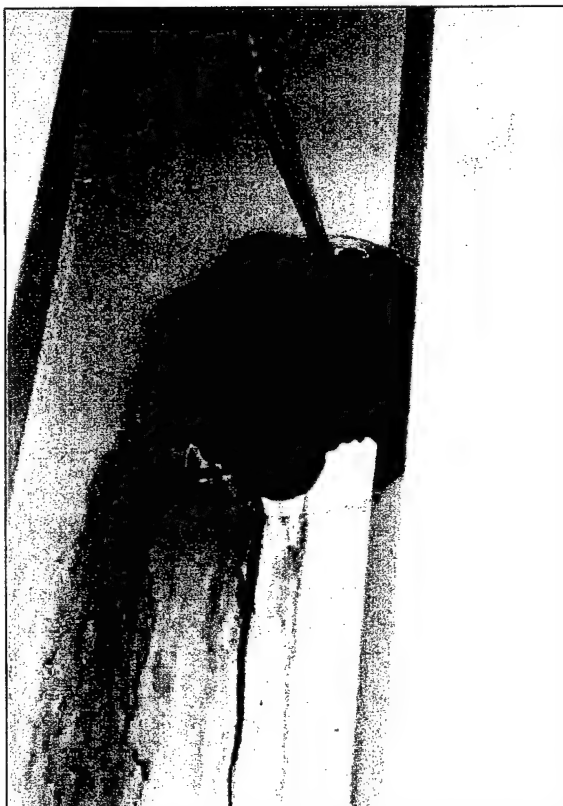
- Prior to the inspection of the upstream face of the gate and waterblasting, an approximately 10-inch diameter paint blister was observed on the downstream side of the skin plate. The blister was located between the middle and top horizontal girders, approximately 7-feet from the left side of the gate (looking downstream) and approximately 6-feet above the transition between the 1/2-inch and 3/8-inch skin plate. The blister did not appear to be leaking water at the time, however, rust stains were observed on and beneath the blister. After waterblasting the upstream surface of the gate, the blister developed several leaks, see Photo. 24 and Photo 25. During the downstream inspection of the gate the blistered paint was removed to expose the hole in the skin plate, see Photo 26. The actual hole through the skin plate was roughly oblong and approximately 1/4-inch wide and 1/8-inch tall.

**Photo. 24: Paint blister and leakage downstream side of skin plate, prior to removal of paint.**

**Photo. 25: Skin plate leak  
prior to removal of  
paint.**

**Photo. 26: Skin plate leak  
after removal of  
paint.**

- The leak was patched by Gus Hernandez, USACE, on October 17th using META-LOX™ Industrial-Grade Metallic Patching Compound, a 2-part epoxy and resin compound.

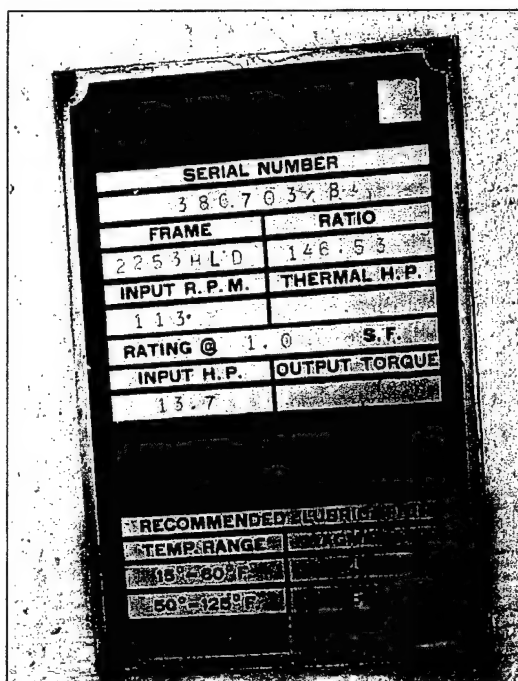
External portions of the hoist equipment, support platforms and gate connections were visually inspected for signs of excessive corrosion, wear or damage. See Photos 29, 30 and 31 below. The hoist and hoist machinery are in generally good condition.

*Photo. 29: Hoist, typical.*

*Photo. 30: Hoist motors, typical.*

*Photo 31: Hoist manufactures plate, typical.*

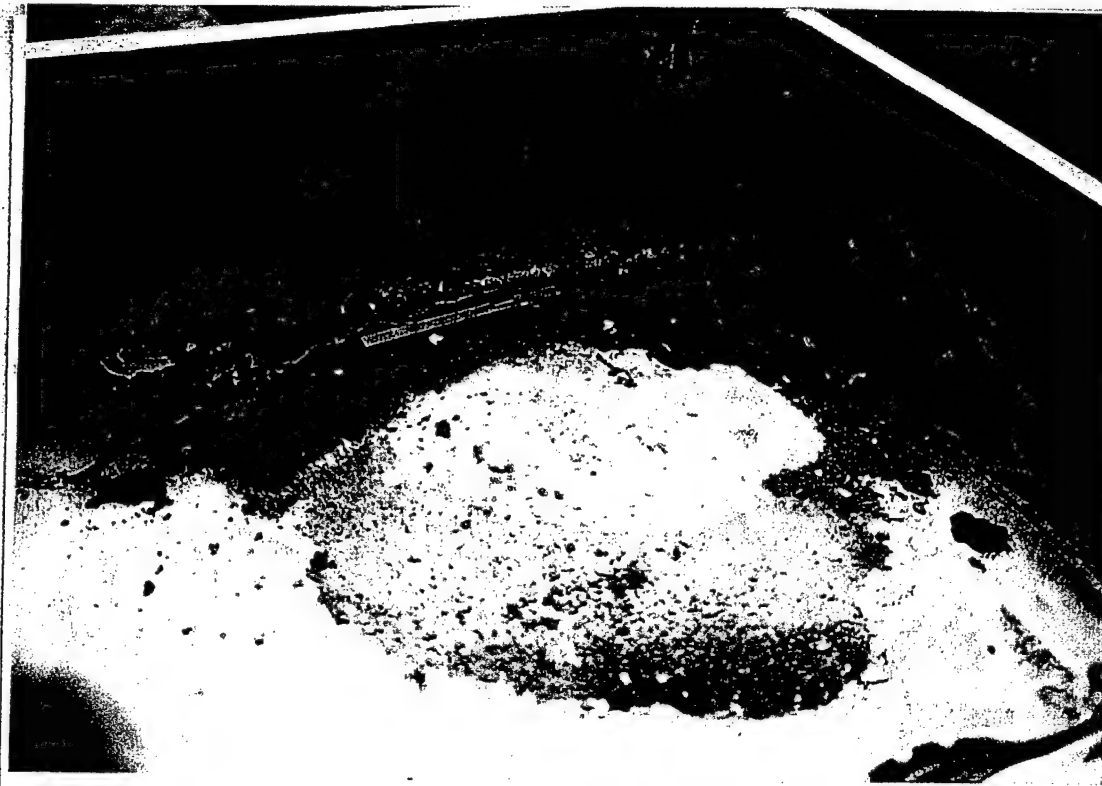
Top horizontal girder, right side,  
between stiffeners at radial strut  
connection. Delaminated paint and  
light corrosion due to poor drainage.

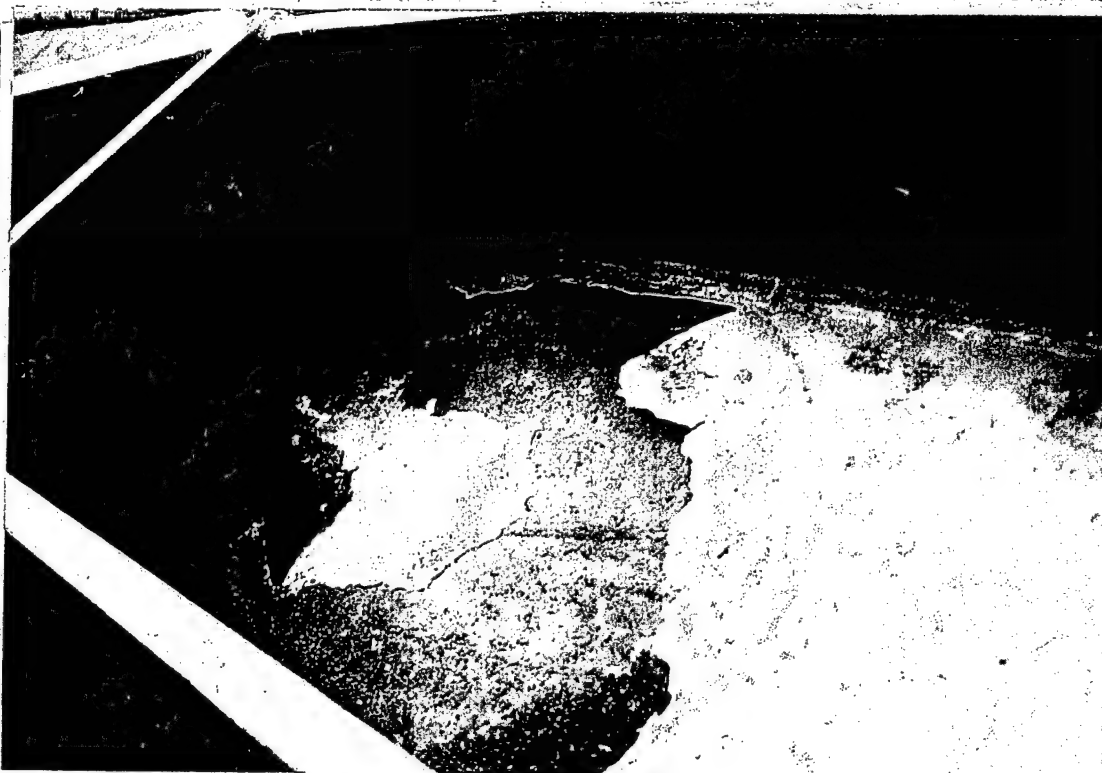
Top horizontal girder, right side,  
between stiffeners at radial strut  
connection. Delaminated paint and  
light corrosion due to poor drainage.

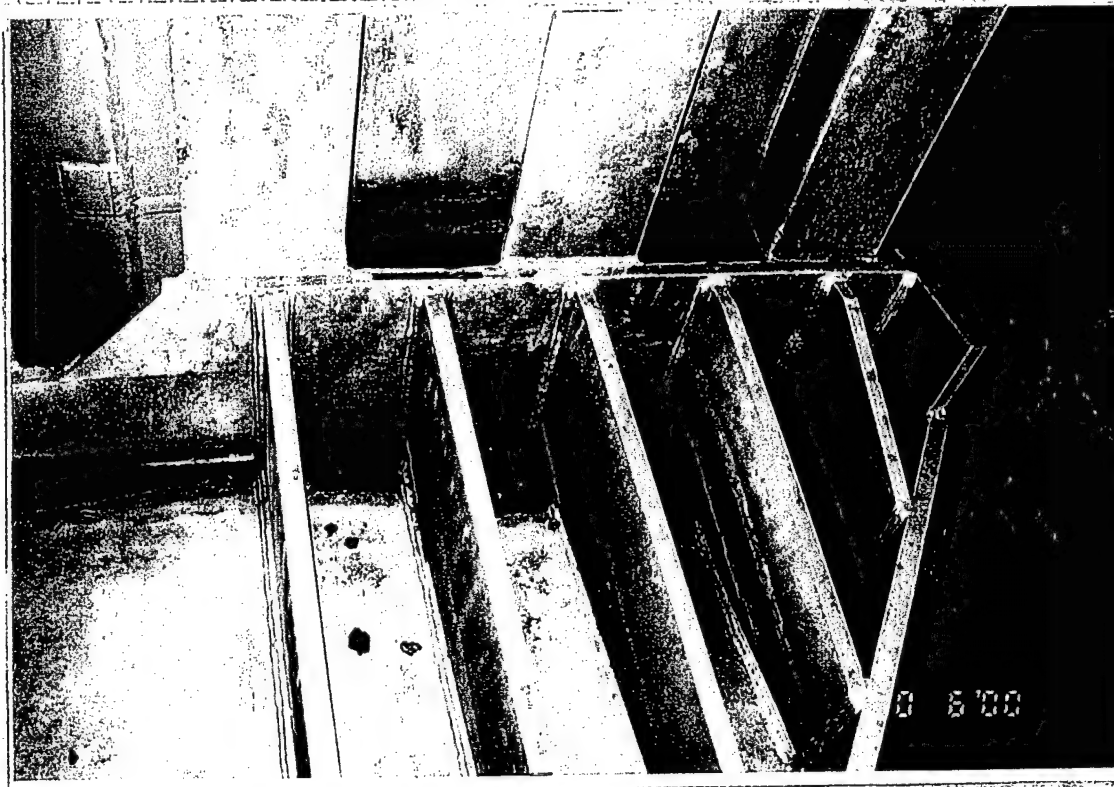
Left end of bottom horizontal girder.  
Standing water, no drainage between  
multiple stiffeners. Horizontal girder  
to skin plate stiffeners, standing  
water, debris and no drainage

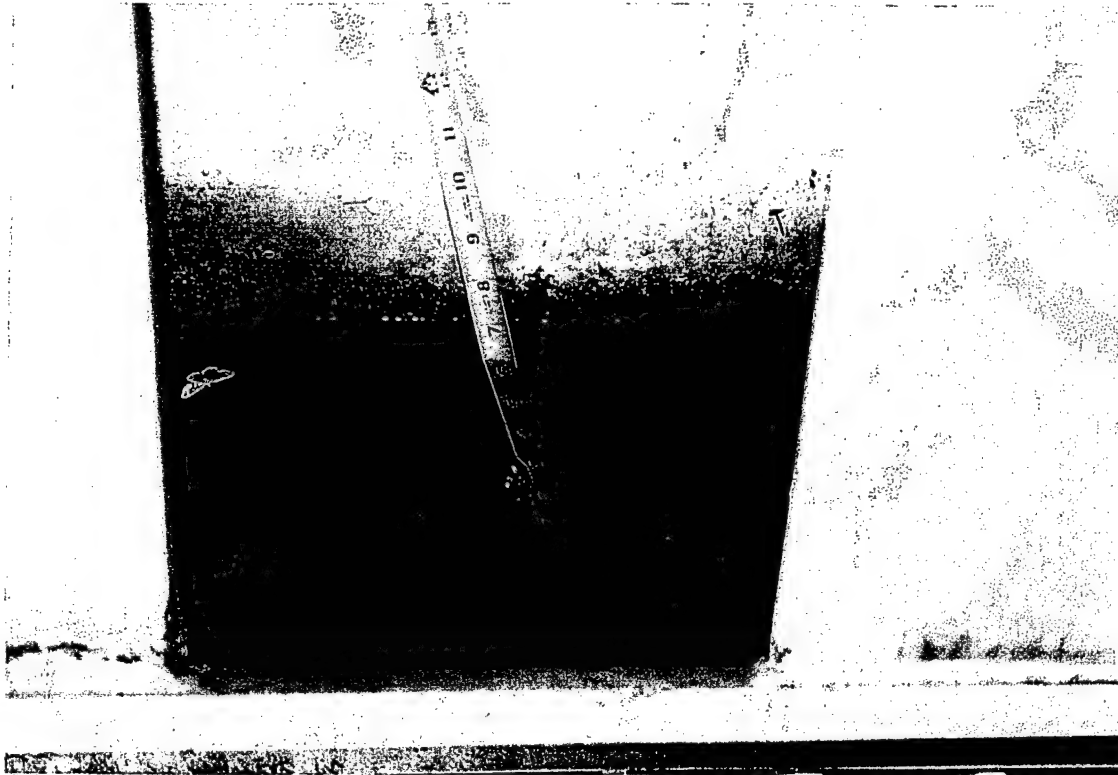
1-7

Gate 1  
Bottom seal closure plate looking  
upstream. Standing water between  
closure plate, purlin webs and  
skinplate. Typical.

- Install drain holes in the downstream portion of the bottom seal plate between every purlin. Note: the rubber bottom seal is located between the bottom seal plate and the bottom seal keeper plate. The hole should not be flame cut with the rubber bottom seal in place. The recommended size for these drain holes is 1-inch in diameter.

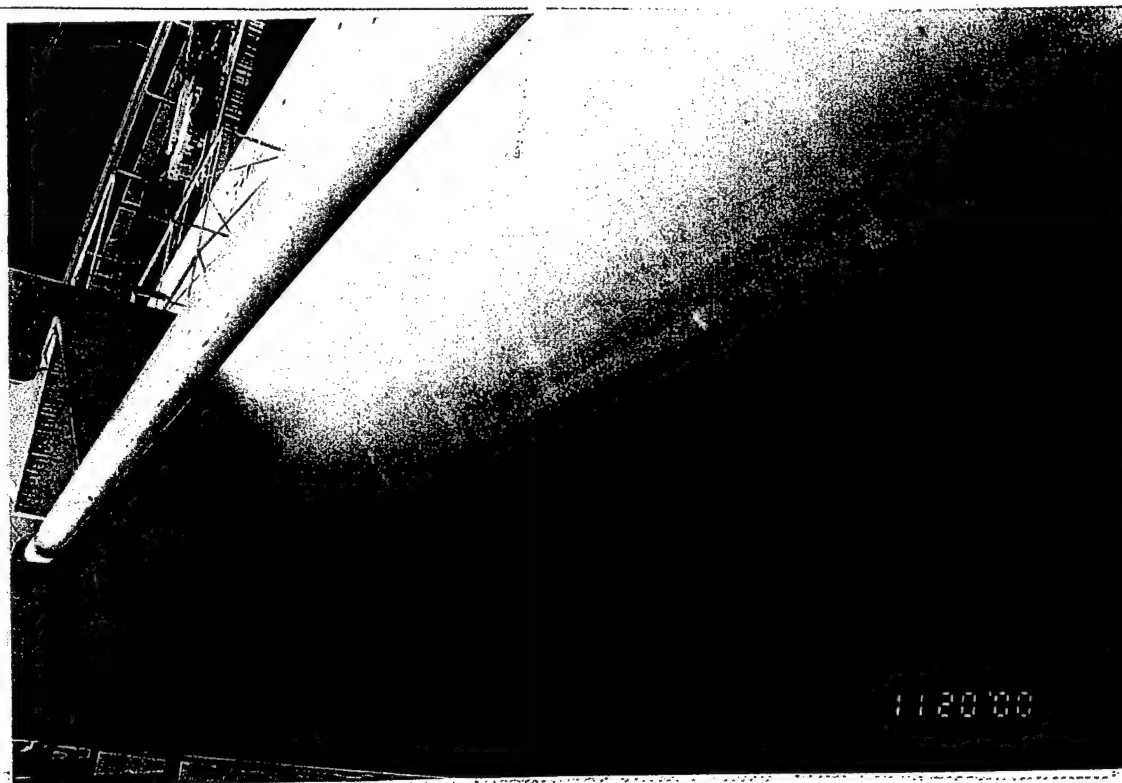
Typical skin plate condition. Light pitting near normal water surface. Note: Surface collector removed.

- Repair pitting on skin plate and repaint (or recoat) upstream surface of gate face.
- Install sacrificial anodes on upstream side of gate. Based on the condition of the skin plate at Little Goose Dam (which has sacrificial anodes) sacrificial anodes will significantly reduce the amount and severity of pitting of the skin plate. A corrosion expert should be consulted to determine the number and location of anodes required.

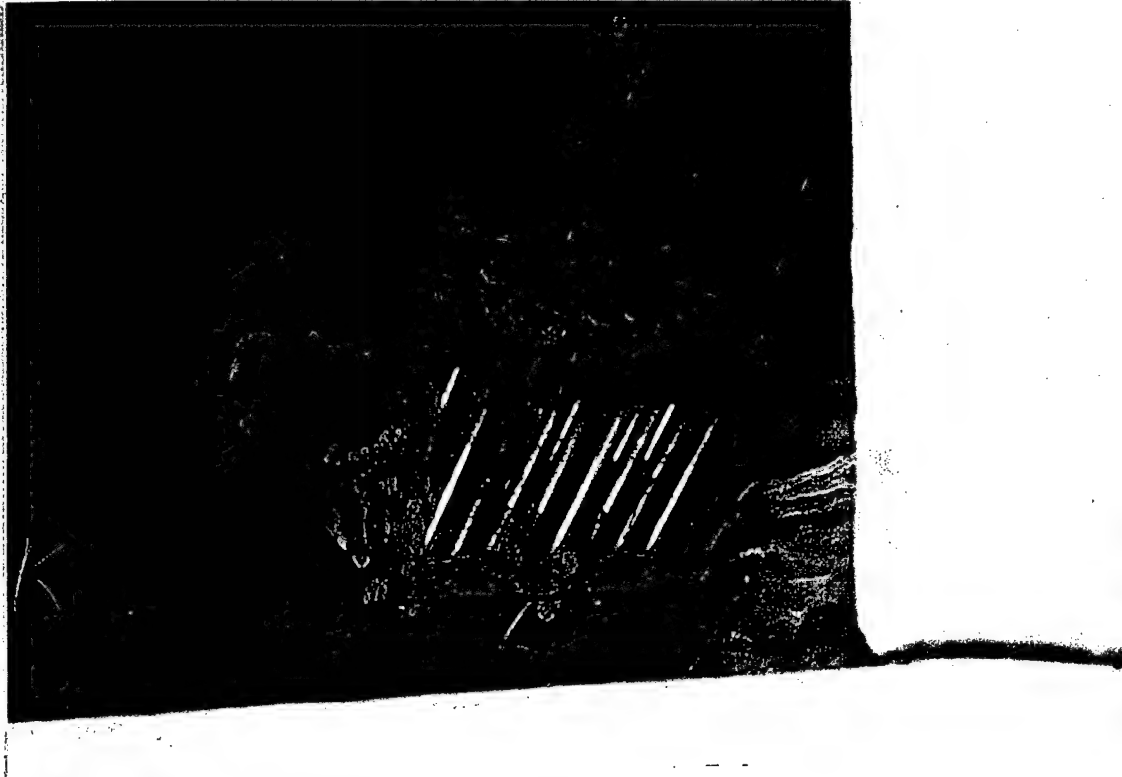
Right side hoist connection. Light corrosion on lifting lugs and plates.  
Note: excellent condition of stainless steel U-bolts.

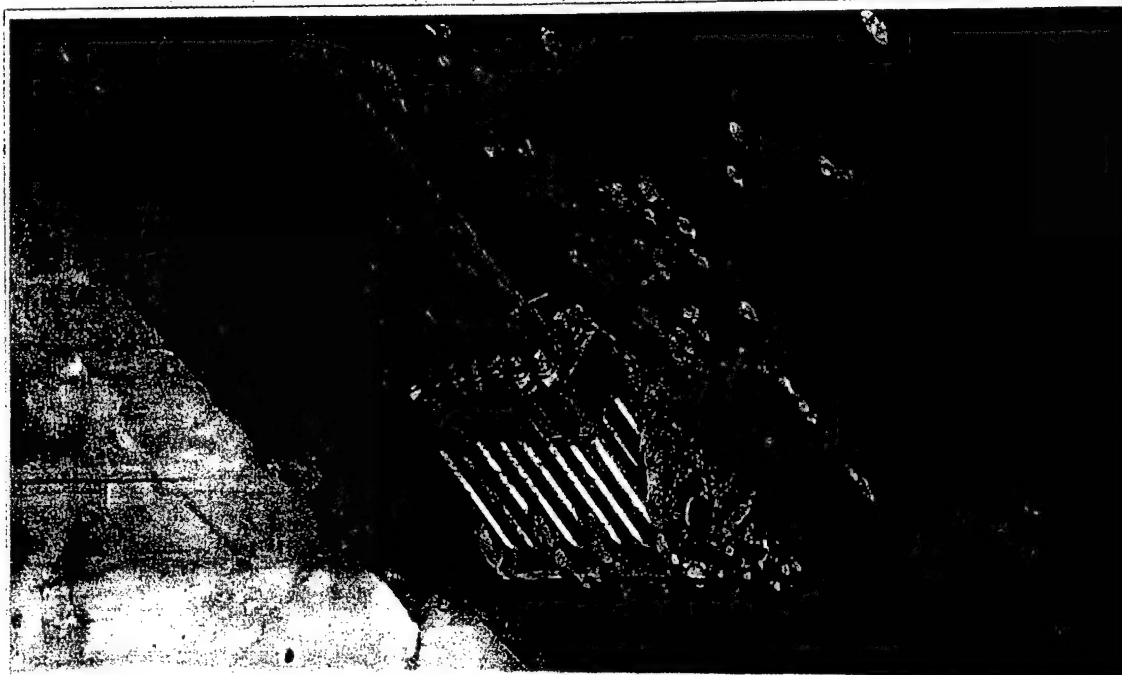
Left side hoist connection. Light corrosion on lifting lugs and plates.  
Note: excellent condition of stainless steel U-bolts.

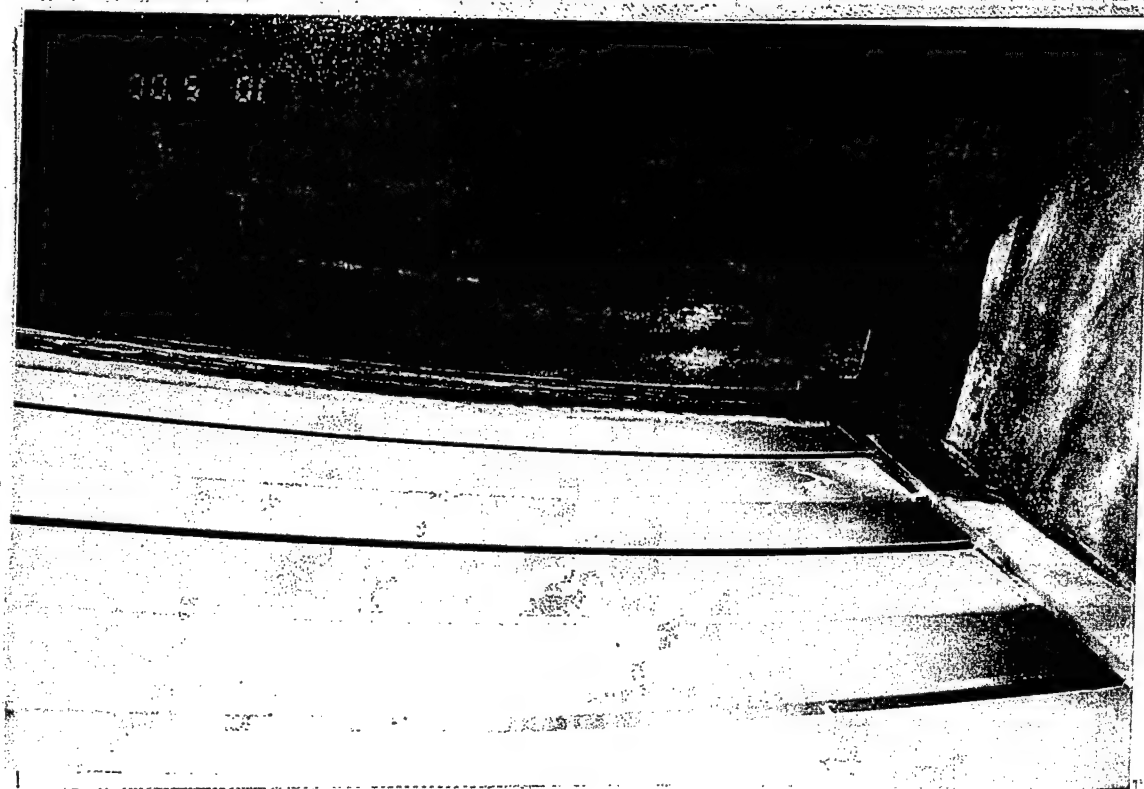
Left end, middle horizontal girder.  
Peeling paint on purlins, light  
corrosion.

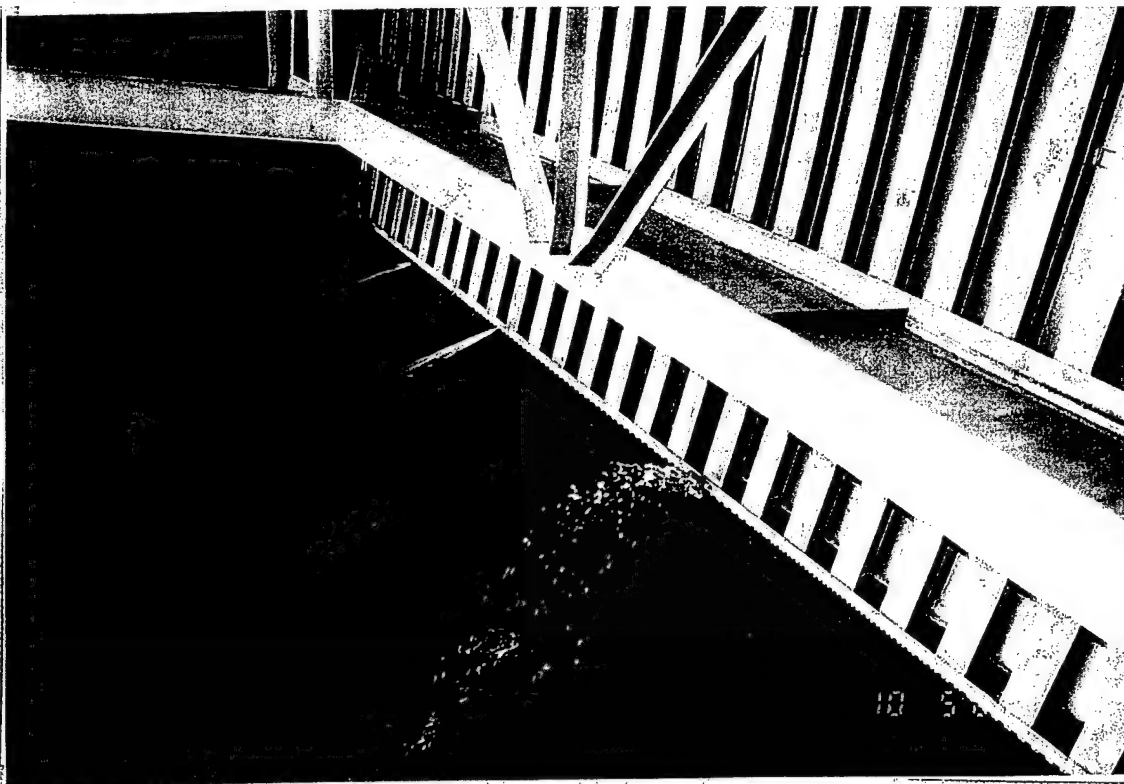
2-6

**Gate 2**  
Bottom / side seal leak at bottom left  
corner of gate.

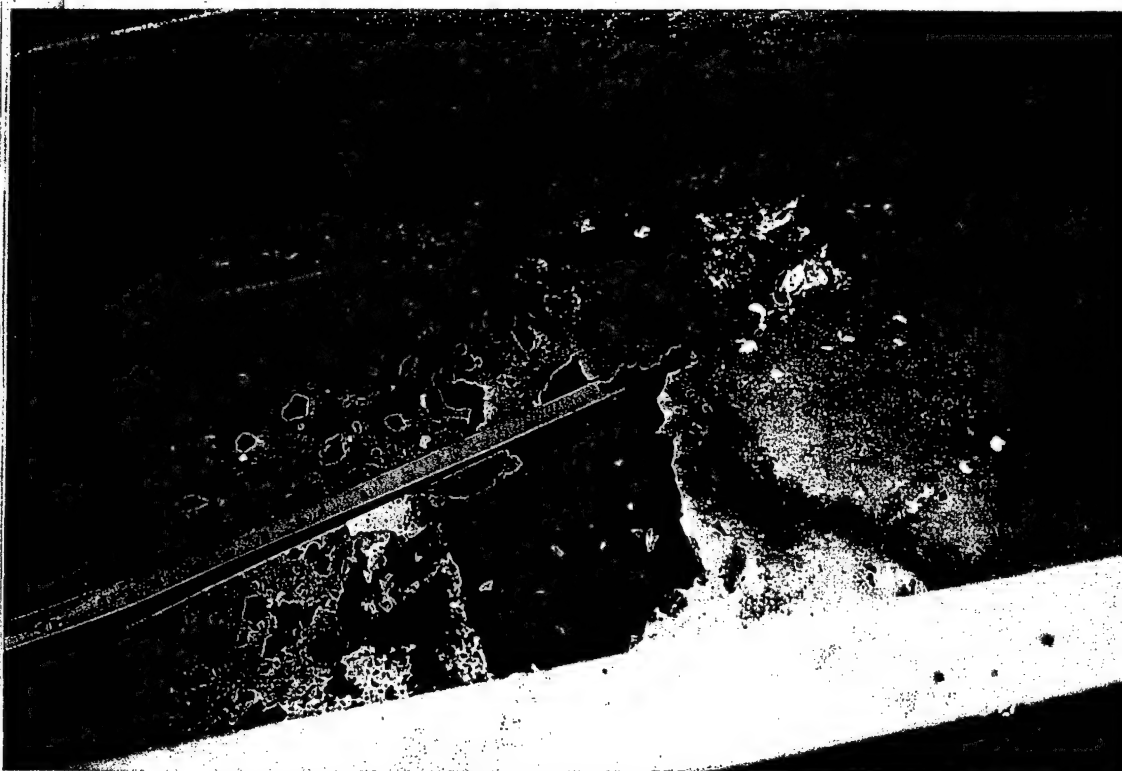
Leak at center construction joint in  
spillway monolith.

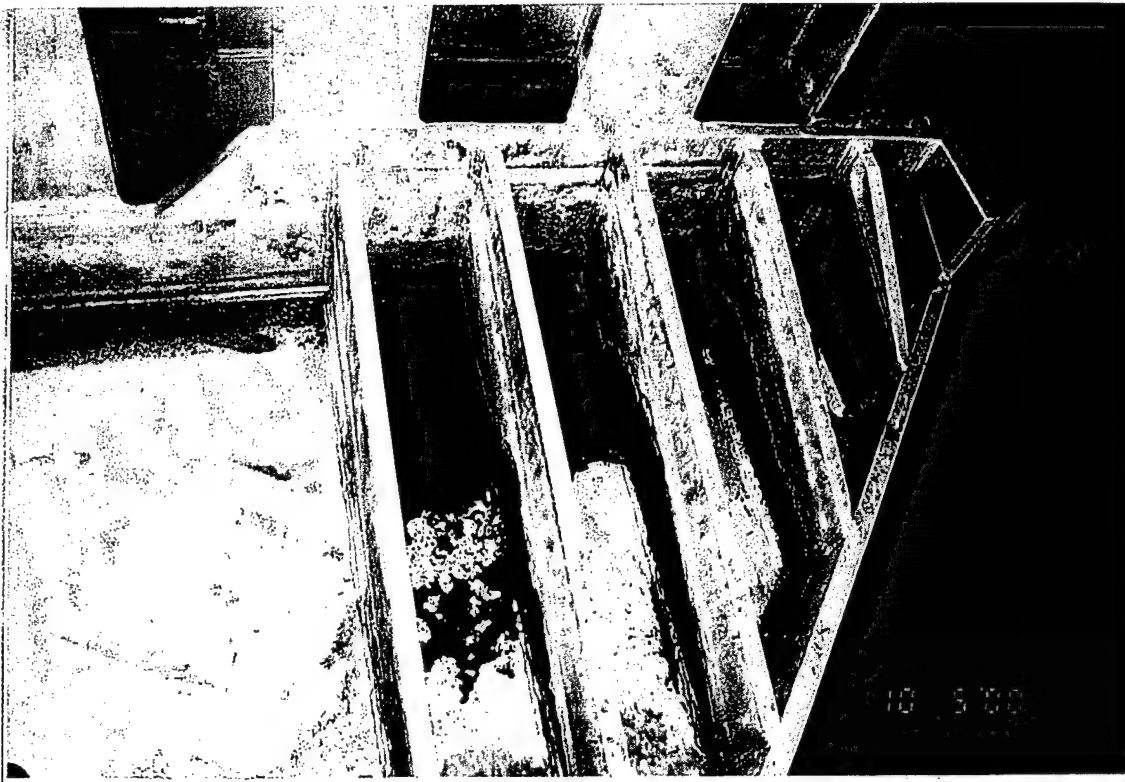
Left end of bottom horizontal girder.  
Standing water, no drainage between  
multiple stiffeners.

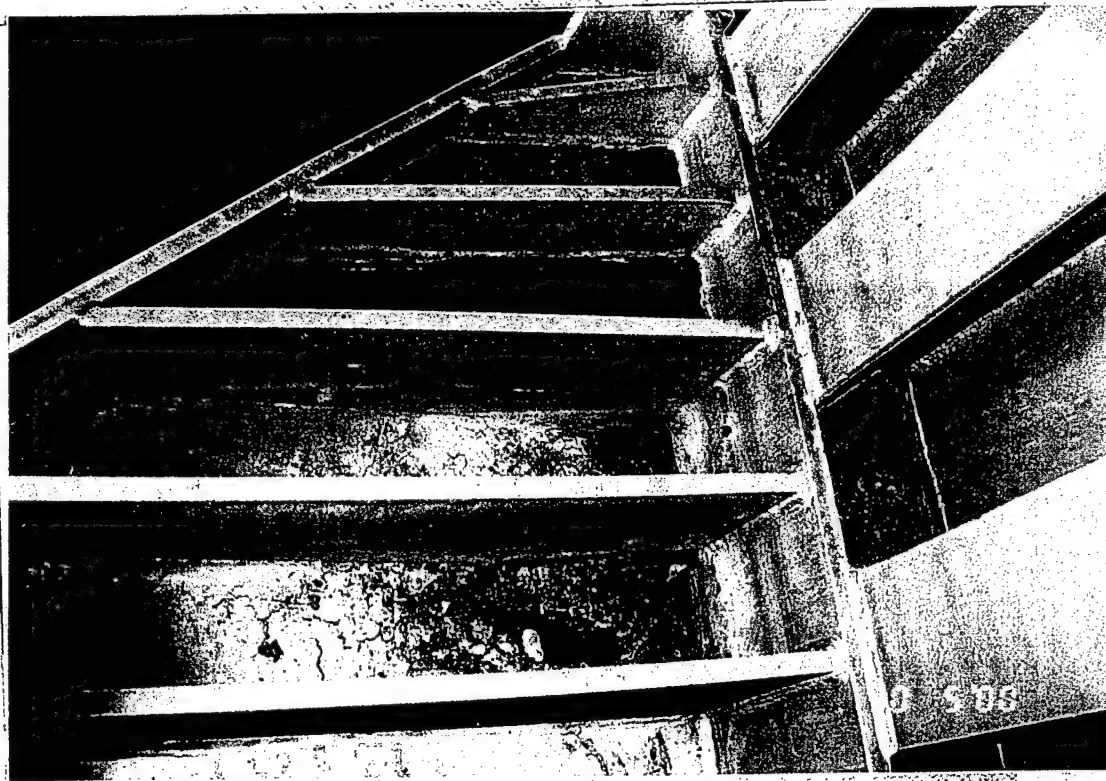
Close-up, right end of bottom  
horizontal girder. Standing water, no  
drainage between multiple stiffeners.

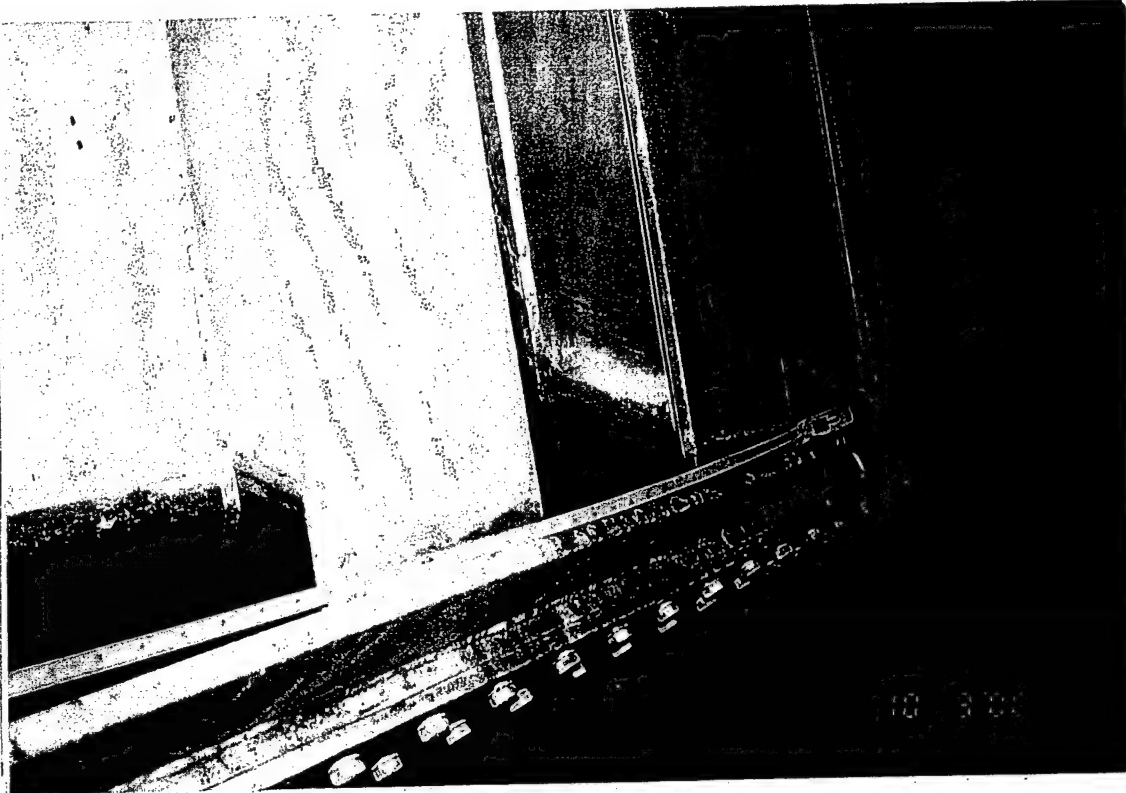
2-18

Gate 2  
Bottom seal closure plate looking  
upstream. Standing water between  
closure plate, purlin webs and  
skinplate. Typical.

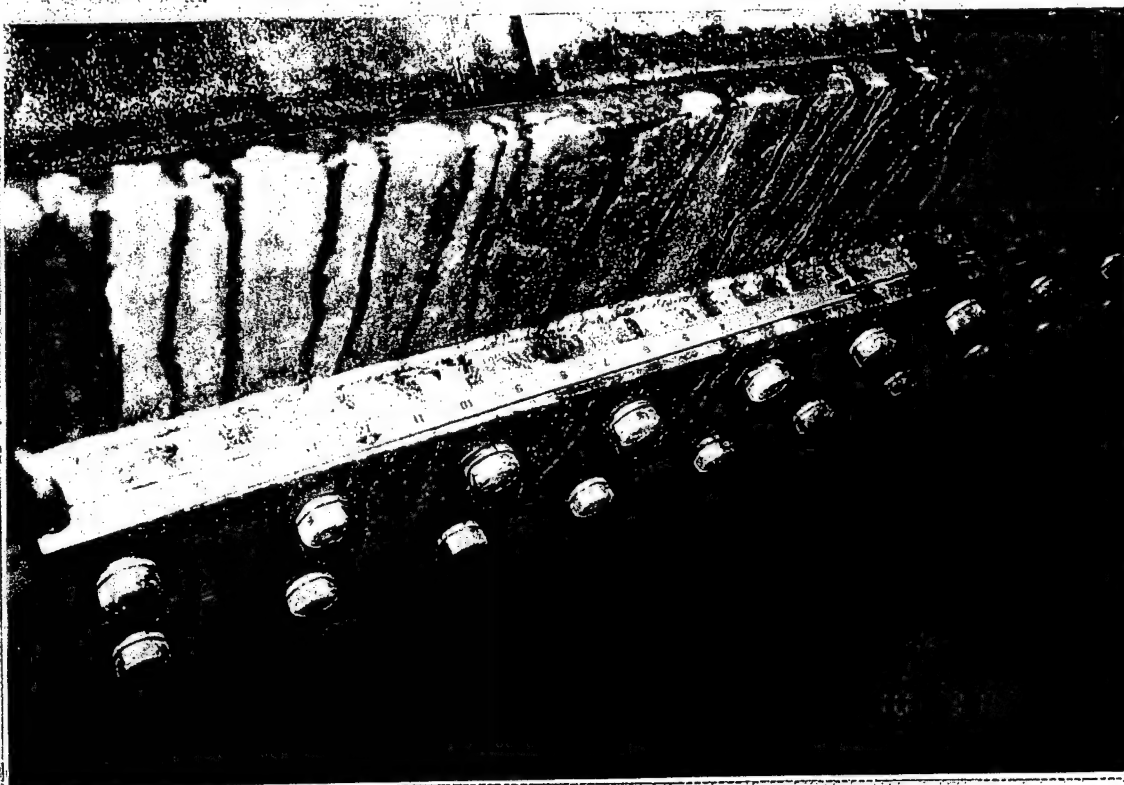
Bottom seal closure plate looking  
upstream. Standing water between  
closure plate, purlin webs and  
skinplate. Typical.

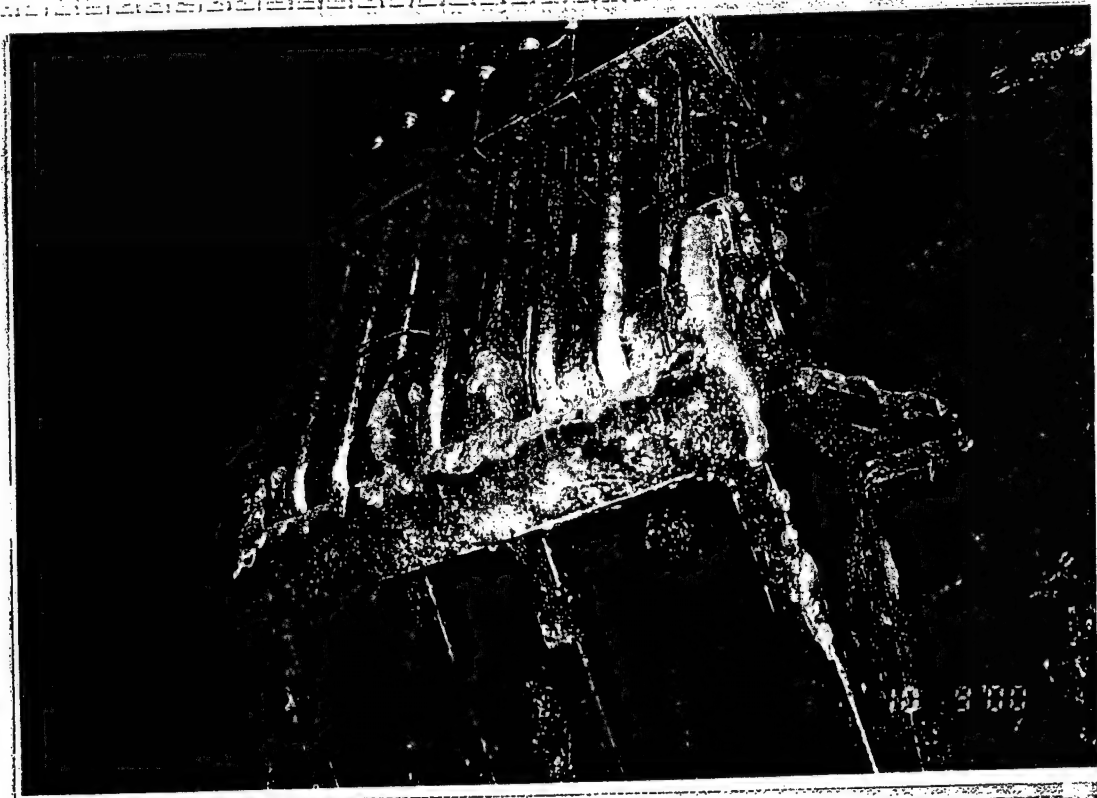
Left side hoist connection. Light corrosion on lifting lugs and plates.

Note: Excellent condition of stainless steel U-bolts.

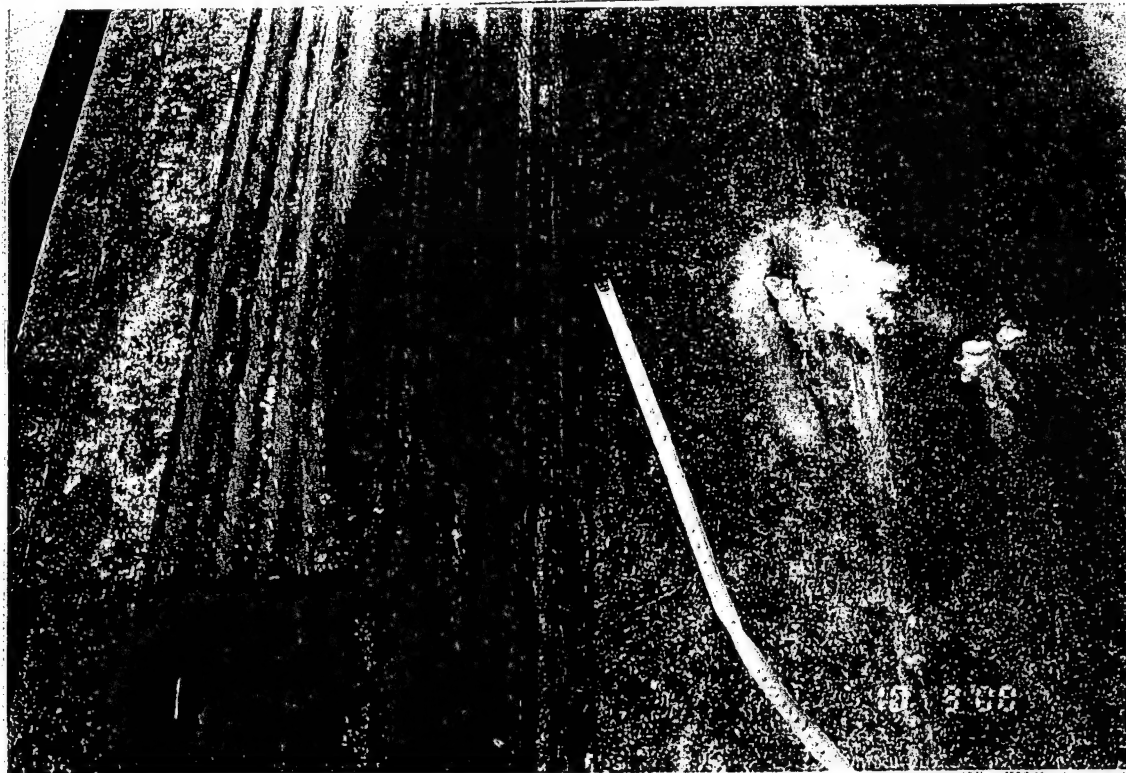
2-33

Gate 2  
Typical pitting.

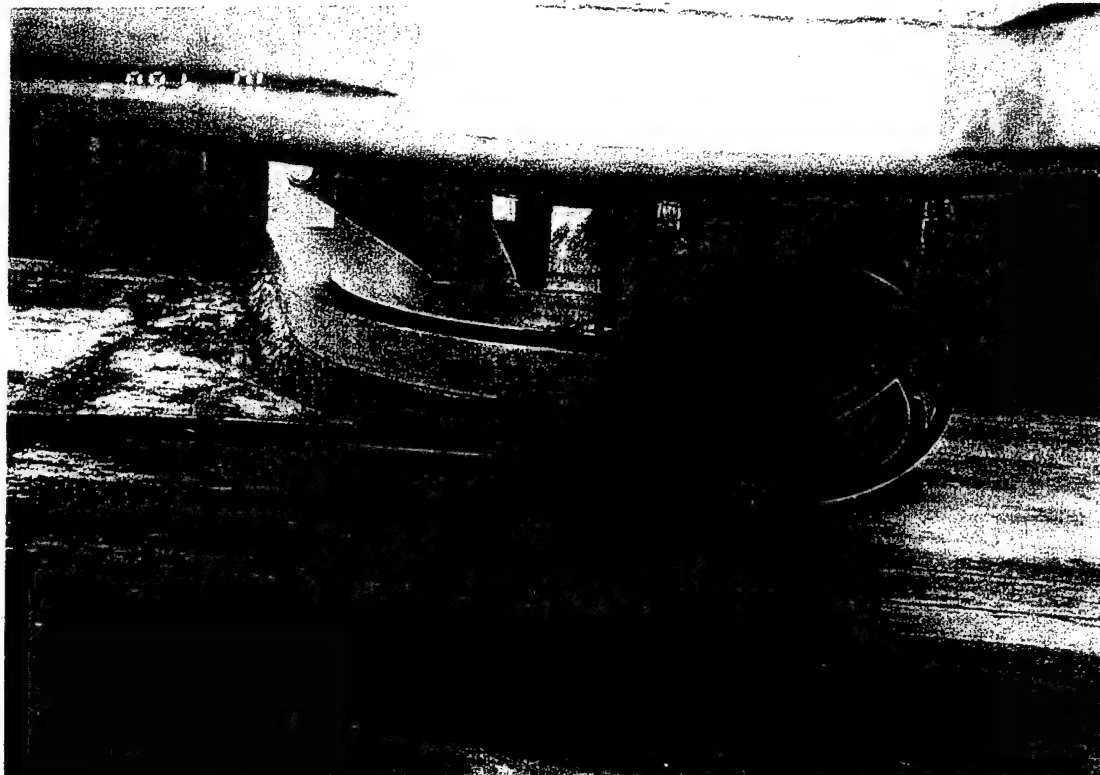
**Gate 3**  
Inside closure plate at right trunnion,  
looking downstream. Staining and  
light corrosion due to drain above.

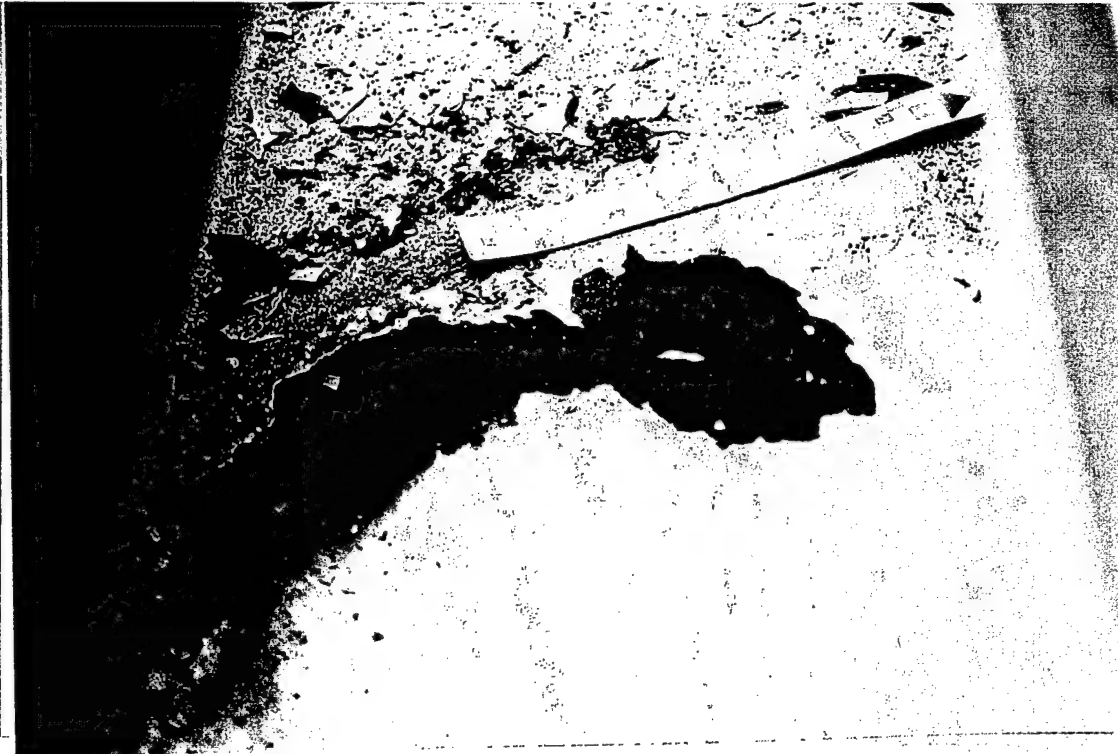
#### Gate 5

Right frame, upstream end of top  
radial strut. Delaminated paint and  
light corrosion on web.

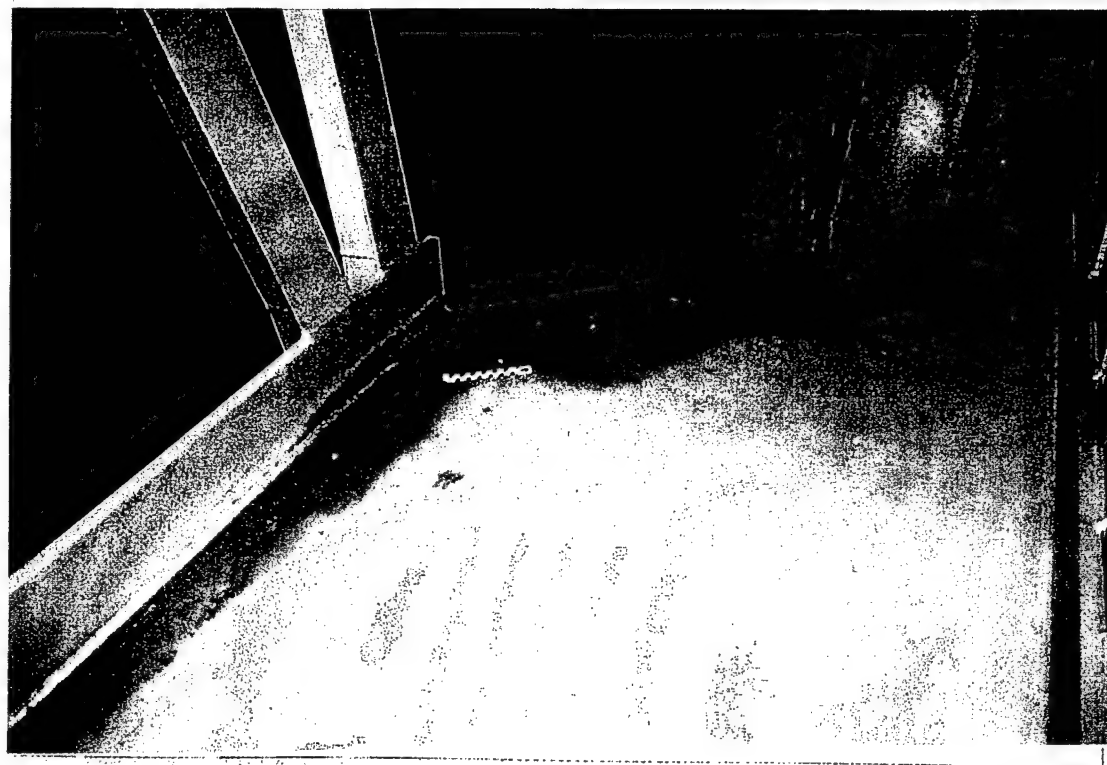
**Gate 5**

Right end of middle horizontal girder.  
Light corrosion due to side seal leak.

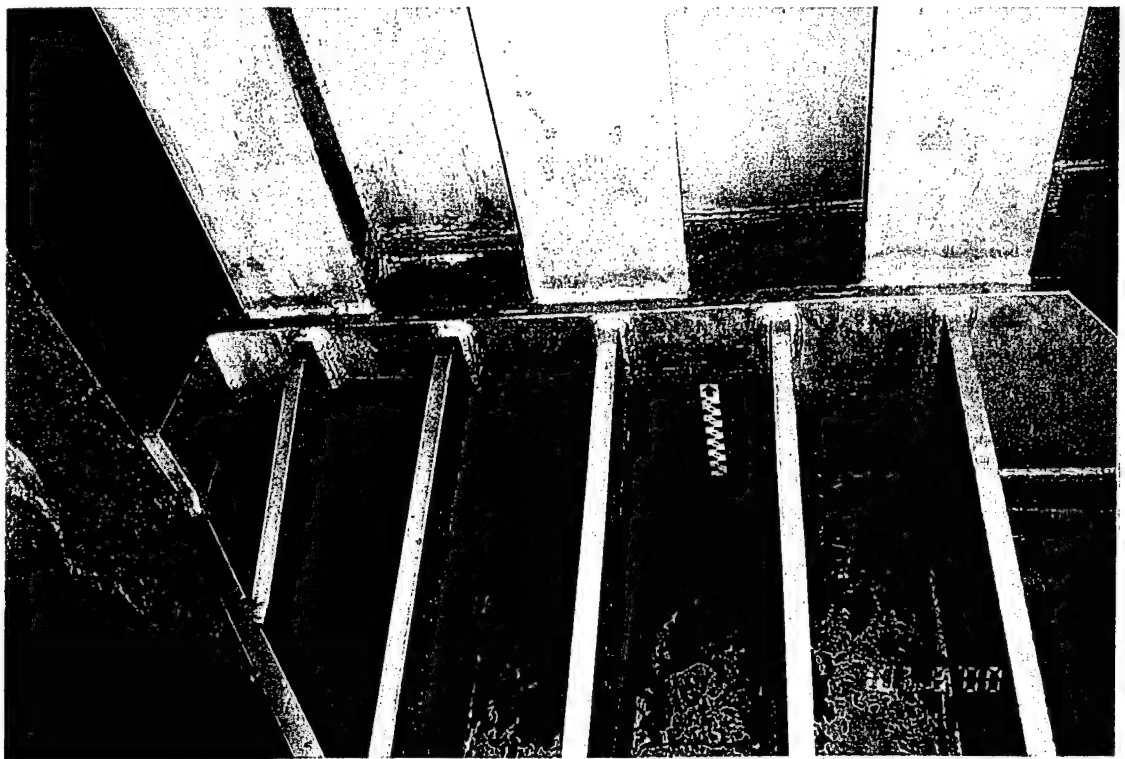
#### Gate 5

Right end of bottom horizontal girder.  
Standing water, no drainage between  
multiple stiffeners. Horizontal girder  
to skin plate stiffeners, standing  
water, debris and no drainage

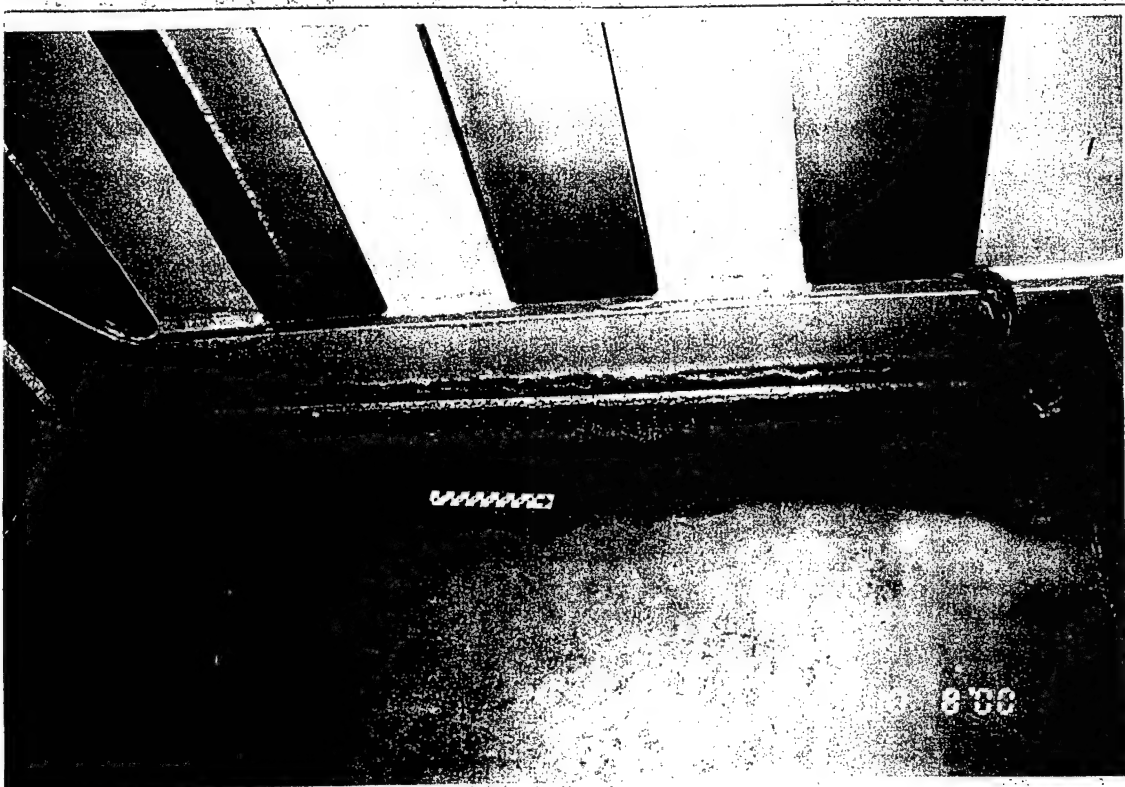
#### Gate 5

Left end of bottom horizontal girder.  
Standing water, inadequate drainage  
between stiffeners.
